# Evaluation and Performance Analysis of Liquefied Petroleum Gas Cylinders

This paper presents the experimental results of the tensile, bending, hardness, hydrostatic testing, and microstructural properties of liquefied petroleum gas cylinders from local sources. The burst pressure and fracture sites were also investigated. In addition, know how LPG cylinders are compliant with ISO 4706 requirements as per standard to get approval and acceptance. The tests were performed on three samples (C1, C2, and C3), and all the tests were according to the specification. Tensile testing was carried out at room temperature (23°C) as per ISO 6892-2016. Tensile test specimens with a gauge length of 50 mm were prepared from the sidewall of cylinders. The equipment used is built up around a 250 KN maximum capacity of (Instron Servo-Hydraulic Testing Machine Model 1332). At the same time, micro-hardness testing was carried out as per ASTM A384. Diamond indenter (pyramid) with a face angle of 136° was used. During testing (1kg) load was applied on the sample with a dwell time of 15 seconds. As for bending tests were carried out in accordance with ISO 7438 for all cylinders to evaluate their welding

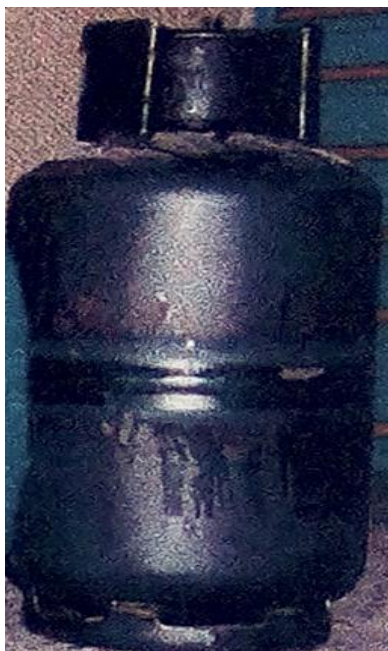
Fig. 2. LPG Cylinder after the Shot Blasting Process

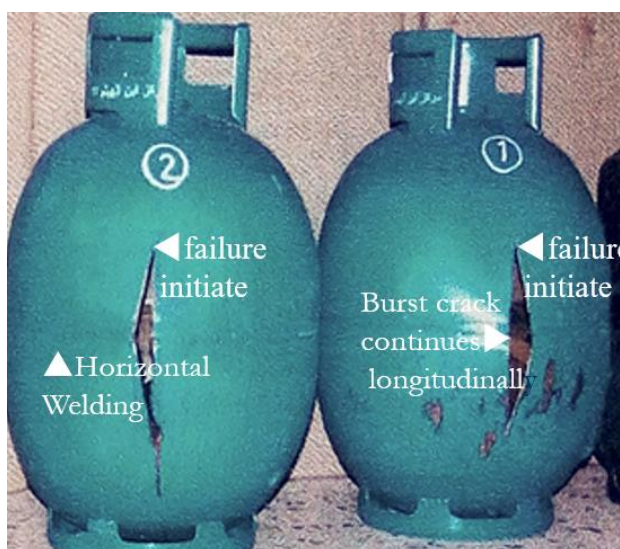
In the test to determine the pressure at which the cylinder burst (BP), we can use this test to obtain other important information such as the volumetric expansion coefficient, the nominal hoop stress (NHS), and the magnitude of the volumetric expansion (VE). These hydro-tests reveal Volumetric Expansion (VE), Burst Pressure (BP) and Nominal Hoop Stresses (NHS). These values are considered as critical parameters in hydro-testing of LPG Cylinders [16,31-33]. This information as noted by Y. Kisioglu et al [32] it can help us to identify other important engineering properties. In the experiment of determining the rupture pressure (BP) as in Fig. 6, it was found that the beginning of crack initiates at the top of the cylinder exactly at its middle but above the ring welding area and then it continues to expand longitudinally as shown in Fig. 6.

**Fig. 6.** Showing the Crack Shape, Length and Position Relative to Welded Region

As indicated in Fig. 6, the shape of the balloon (circumferential and longitudinal expansions) is an indication of a permanent deformation that has occurred, but in all cases, it is important to calculate it because there is a limit to the deformation allowed in the ISO 4706 standard, which requires that these values do not exceed the number  $\geq 15\%$  of the initial volume of the cylinder. The magnitudes of expansions measured manually from the LPG cylinders after burst experiments. Based on these measurements, the permanent volume expansions were about  $24\% \pm 1$  of the initial volume of the cylinders. In other terms, the amount of permanent volume expansions can be calculated by dividing the volume at which the cylinder burst ( $9002.425\text{ cm}^3$ ) / original volume ( $36009.7\text{ cm}^3$ )  $\times 100 = 25\%$ , where ( $9002.425\text{ cm}^3$ ) is the amount of cylinder volume increase and is registrar on the hydrostatic test machine at the same second of cylinder burst. This obtained result conform with ISO 4706 requirements.
